**GENERAL DIRECTION OF CIVIL AERONAUTICS ACCIDENT PREVENTION  
DEPARTMENT**

**PRELIMINARY REPORT OF AVIATION INCIDENT No. 2052-24**

**DATE: March 11, 2024**

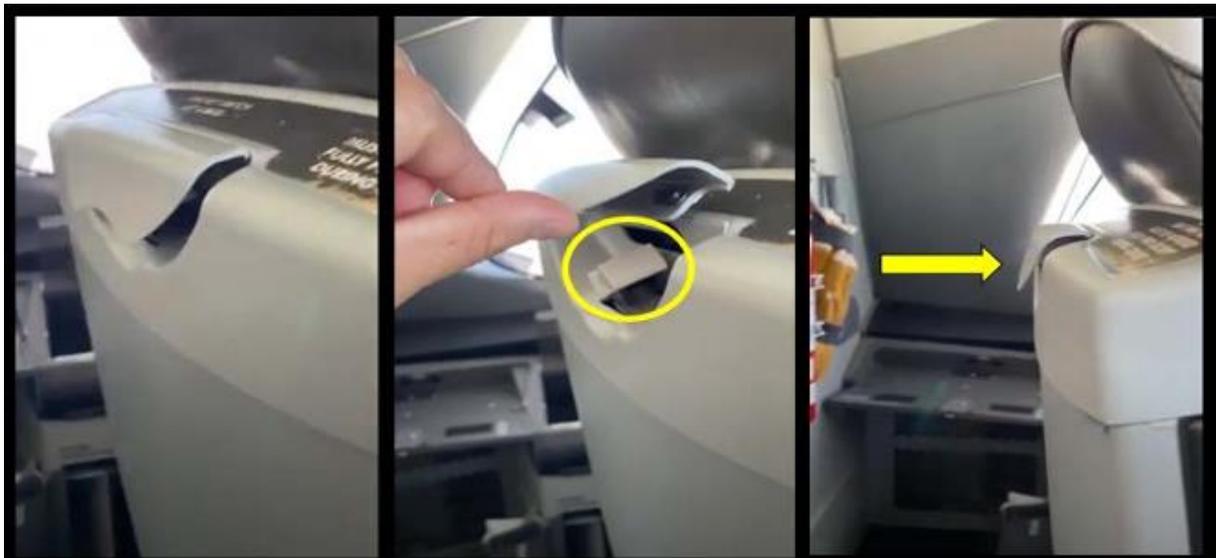
Images N°1, 2, and 3: Captain's seat.

A photo and video set was conducted on the condition of the Captain's seat (left side of the cockpit) according to images N°1, 2, and 3.

- At the time of the incident, the aircraft was established at flight level 041 (41,000 feet).
- The seat on the left side of the cockpit, with the captain in position, began an involuntary movement forward.
- The recovery of the aircraft by the flight crew from an unintended descent of approximately 400 feet did not exceed the positive or negative loads allowed by the manufacturer for this type of flight condition.
- The meteorological conditions and lack of turbulence at the time of the incident were not causal or contributing factors in the operation.

- Sending the EAFR equipment (FDR/VCR) to the National Transportation Safety Board (NTSB) of the USA for reading and analysis.
- Coordination with the Federal Aviation Administration (FAA) of the USA and the manufacturer Boeing of the USA to perform the physical inspection of the seat.

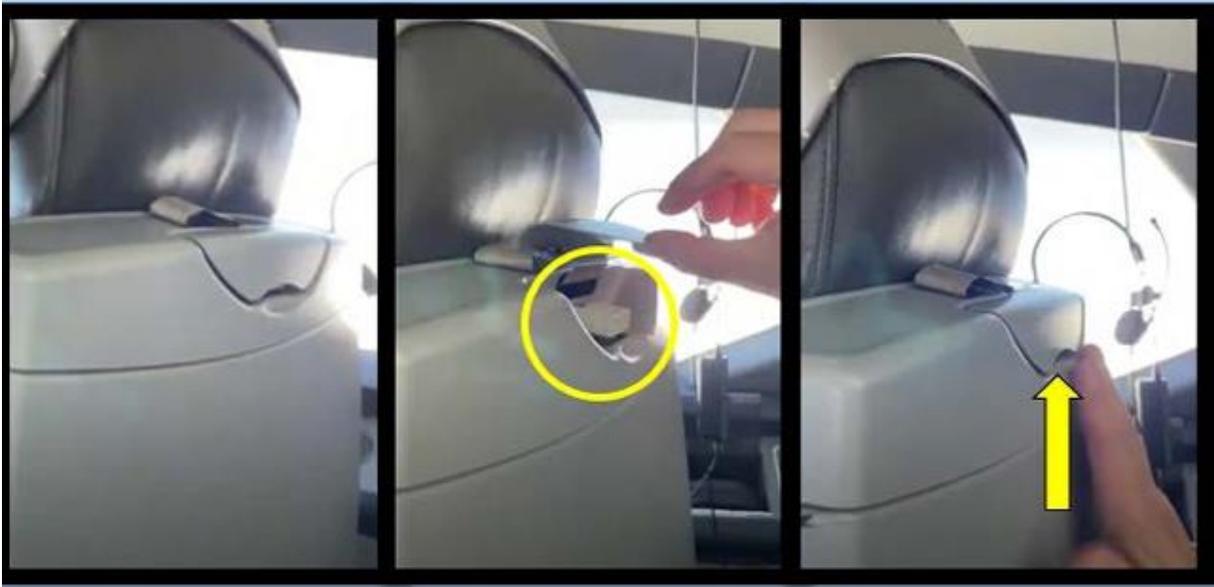
Images N°4, 5, and 6: First Officer's seat.

A photo and video set was conducted on the condition of the First Officer's seat (right side of the cockpit) according to images N°4, 5, and 6.

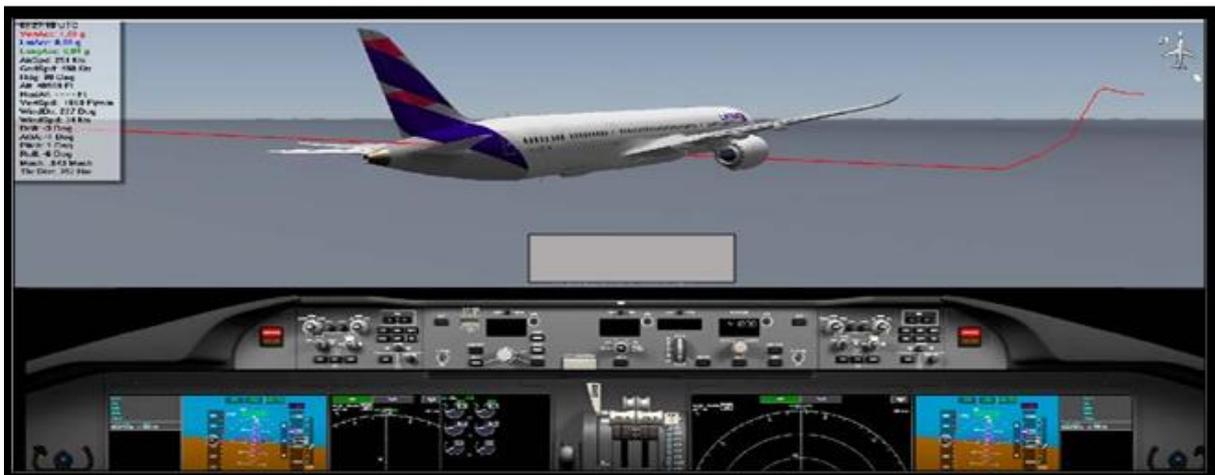
Image N°7

A recreation was visualized with the flight data at the time of the incident, performed by the operating company, according to image N°7.

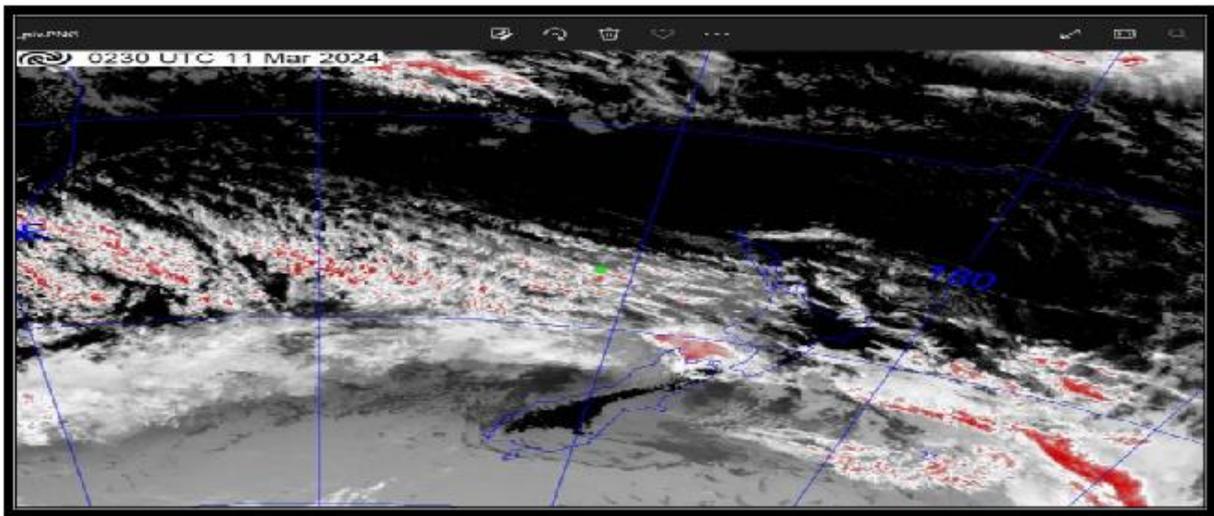
Image N°8

In summary: from an initial assessment, no adverse conditions for flight were observed according to images N°8 and N°9.

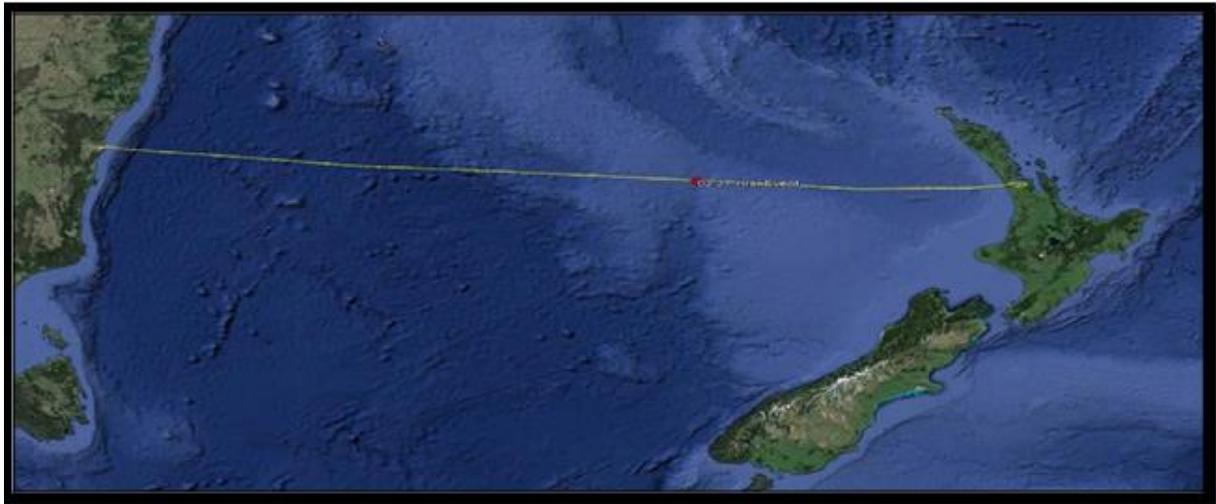
Image N°10

The incident occurred during a commercial flight from Kingsford Smith International Airport in Sydney, Australia, to Auckland International Airport, New Zealand (international airspace), while the aircraft was en route at flight level 410, as per image N°10.
